Manhole Inspection Summary

Manhole # S25Q__007MH

Insp Date: **4/8/08 2:39 PM**

Location Address: **15 W.HAMBURG ST.**

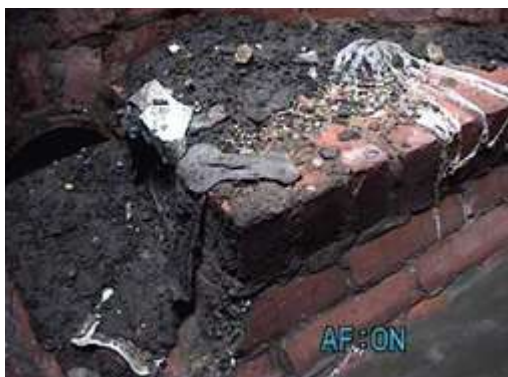
Defect 6

Condition: ☐ Sound ☐ Cracked ☐ Root Intrusion ☐ Deteriorated ☐ Leaks ☒ **Debris**

Bench and Channel Debris

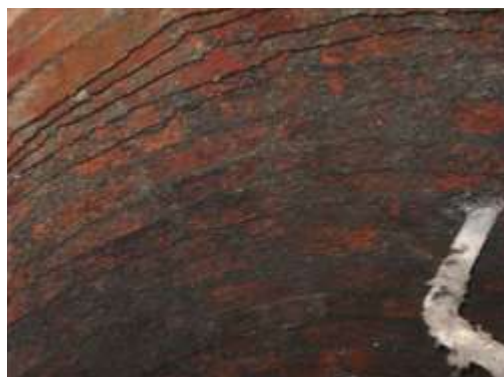
Defect 4

Infiltration: ☐ None ☐ Joint ☐ Cracks ☐ Mortar ☐ Roots ☒ **Wall**

EVIDENCE OF INFILTRATION CORBEL AND BARREL

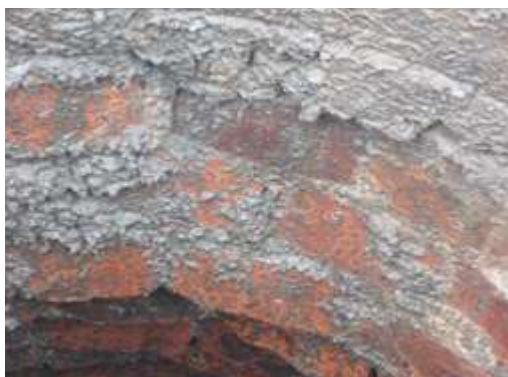
Defect 3

Infiltration: ☐ None ☐ Joint ☐ Cracks ☒ **Mortar** ☐ Roots ☐ Wall

EVIDENCE OF INFILTRATION AT CHIMNEY AND CORBEL MUD DEPOSITS

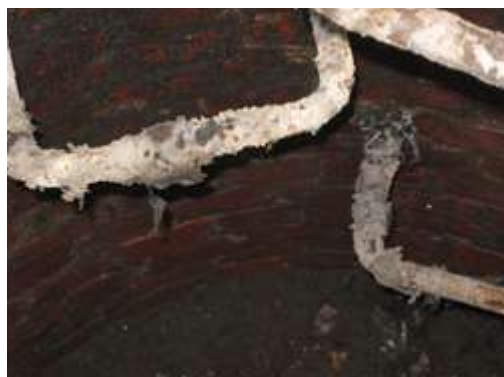
Defect 1

Count: **3** Missing: **0** ☒ **Corroded**

☒ **Evidence Of Surcharge** Depth: **4** (ft.) ☐ Active Surcharge Present

EVIDENCE OF SURCHARGE ON STEPS AND EVIDENCE OF BARREL INFILTRATION

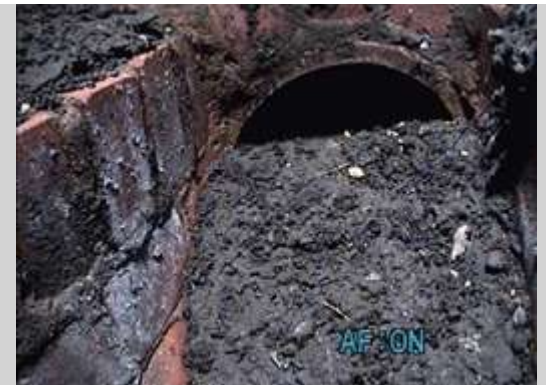
2 O'Clock Inflow

debris build up in channel

Pipe Height: **8.4** (in.) Rod and Bar (Angled)
Pipe Material: **Clay** ☐ Pipe Lined
Invert Depth: **7.75** (ft.) Flow Characteristics: **None**
Deposits: ☐ None ☐ Mud ☒ **Sludge** ☐ Debris ☐ Grease
Silt Depth: **7** (in.) Deposits Extent: **Heavy**
Infiltration: **None** Pipe Seal Cond: **Unknown**

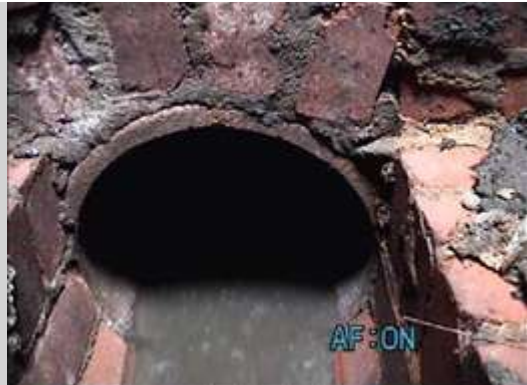
6 O'Clock Inflow

Infiltration: **Evidence** Pipe Seal Cond: **Unknown**
